# Manhole Inspection Summary

Manhole # S15QQ\_025MH

Insp Date: **8/7/07 11:37 AM**

**Location** Address: **2601 FAIRVIEW AVE**

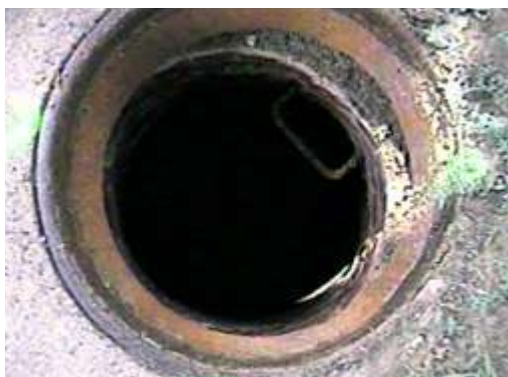
Top View

Offset: **2.5** (in.)

FRAME OFFSET

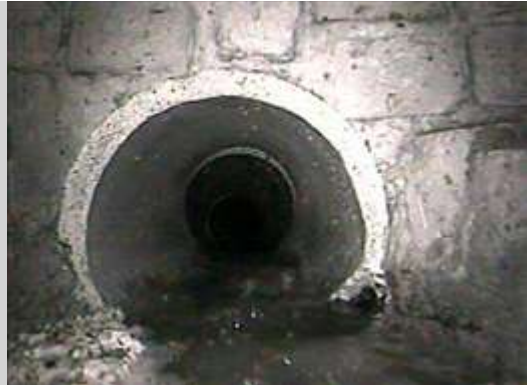
12 O'Clock Outflow

8 in. Circular Gravity Sewer  
Pipe Out @ 12 O'Clock

Pipe Material: **Clay** ☐ Pipe Lined

Invert Depth: **9.45** (ft.) Flow Characteristics: **Slow**

Deposits: ☒ None ☐ Mud ☐ Sludge ☐ Debris ☐ Grease

Infiltration: **None** Pipe Seal Cond: **Sound**

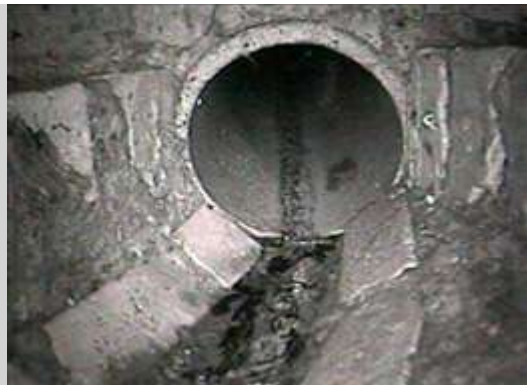
3 O'Clock Inflow

8 in. Circular Gravity Sewer  
Pipe In @ 3 O'Clock

Pipe Material: **Clay** ☐ Pipe Lined

Invert Depth: **9.41** (ft.) Flow Characteristics: **Slow**

Deposits: ☒ None ☐ Mud ☐ Sludge ☐ Debris ☐ Grease

Infiltration: **None** Pipe Seal Cond: **Sound**

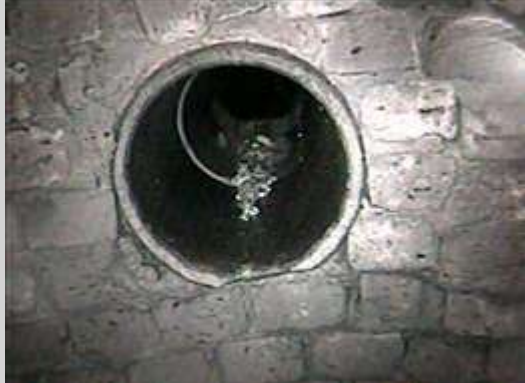
6 O'Clock Inflow

Pipe In @ 6 O'Clock

Pipe Material: **Clay** ☐ Pipe Lined

Invert Depth: **7.50** (ft.) Flow Characteristics: **Slow**

Infiltration: **None** Pipe Seal Cond: **Sound**

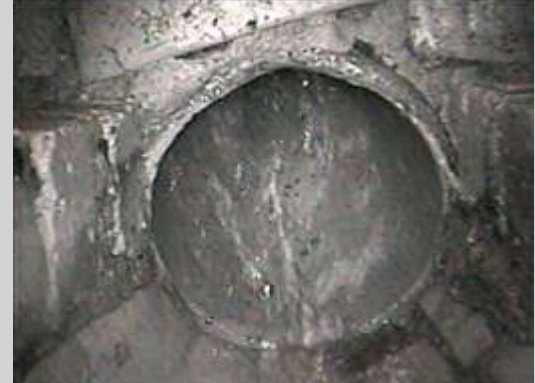
Drop In @ 6 O'Clock

Drop: **Outside Direct**

Inv Depth: **9.74** (ft.)

Drop Condition: **Open**

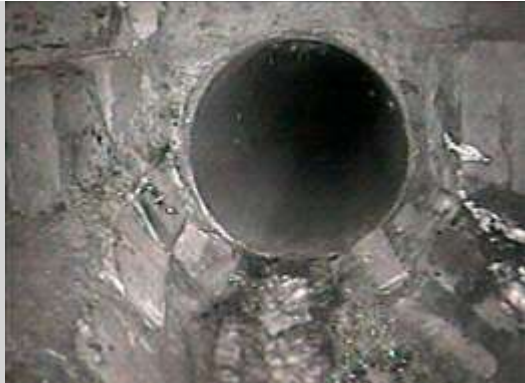
9 O'Clock Inflow

Pipe In @ 9 O'Clock

Pipe Material: **Clay** ☐ Pipe Lined

Invert Depth: **9.48** (ft.) Flow Characteristics: **Slow**

Deposits: ☒ None ☐ Mud ☐ Sludge ☐ Debris ☐ Grease

Infiltration: **None** Pipe Seal Cond: **Sound**
